File: Eureka-Arcata Highway 101 Corridor Improvement Project
HUM 101 / PMS 79.9 / 86.3
01-36600 / 0100000127

SUBJECT: CDP 1-18-1078 Special Condition 1, 2021 Annual Report

Special Condition 1. Sea Level Rise and Flooding Impact Monitoring and Reporting

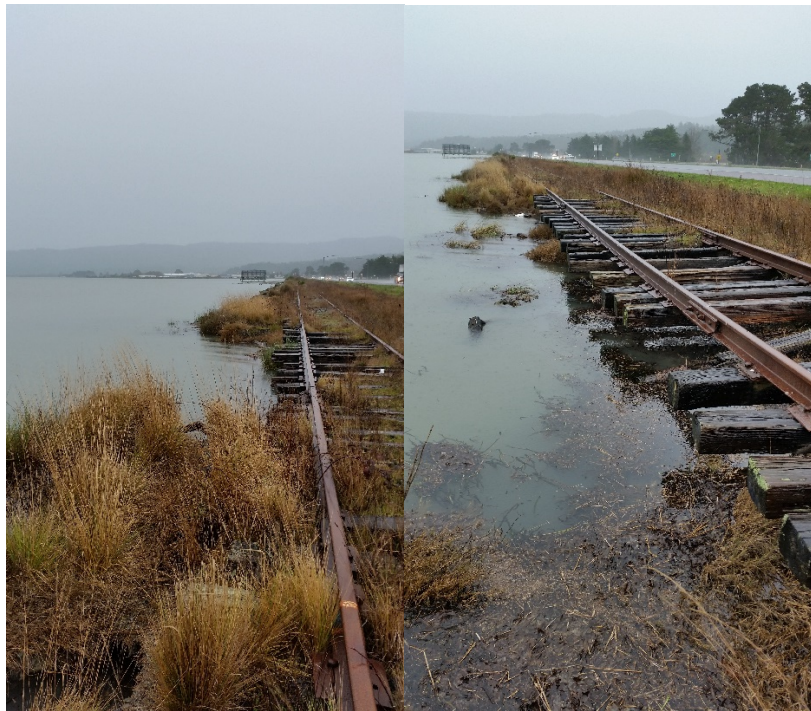
Indianola North Railroad Erosion 1/12/21
