1 LIQUEFACTION: INTRODUCTION

2.2 Liquefaction Potential along the HWY 101 Corridor

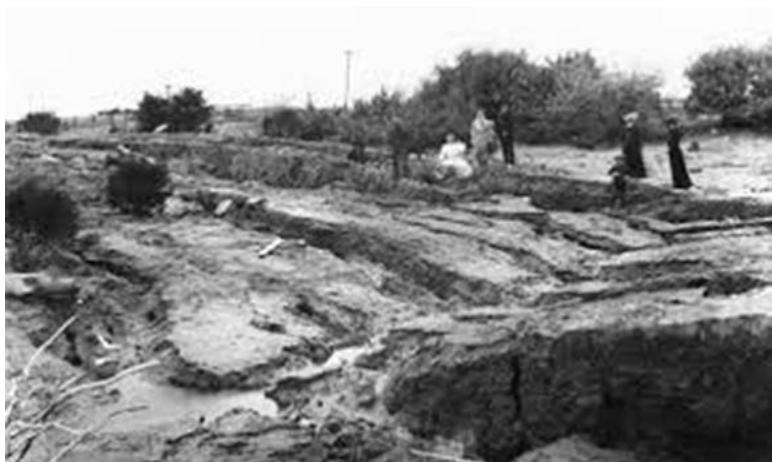
Figure 4. Historical photograph of lateral spreading from liquefaction along the lower Eel River, at Port Kenyon, Humboldt County, triggered by the 1906 earthquake on the San Andreas fault. (Original photograph by E. Garrett; from Dengler, 2008, her Figure 11.)

Deformation from liquefaction in 1906 was extensive in the Eel River valley area, including the community of Port Kenyon (Figures 3 and 4), and included large areas of lateral spreading, ground settling, and sand boils. An eyewitness account by A.S. Eakle (Lawson, 1908, p. 165), a U.C. Berkeley geology professor who surveyed the region 3 weeks after the earthquake, describes the deformation in the Eel River valley as follows: *"At Dungan's Ferry, on the north bank of the Eel River, the ground was full of fissures. Every bar on the river had been opened by fissures, and the gravel toppled over leaving big ditches, some 6 feet deep and over 500 feet long. Coming up on the mainland the road had dropped about 2 feet in one place and was full of small fissures. A 40-acre field was entirely ruined. It was heavily fissured, having dropped down in strips from 2 to 6 feet wide, from 4 to 6 feet deep, and from 5 to 500 feet long, the fissures pointing between south and southwest. All the fields were full of quicksand volcanoes, some 1 to 3 cubic yards in size. They were perfect miniature volcanoes, everyone having a crater. It is said they extended 30 miles up the river."* The community of Ferndale sustained extensive damage from the 1906 earthquake, but although ground settling from liquefaction was indicated for the 1954 earthquake (Youd and Hoose, 1978), the extensive damage to buildings and homes in 1906 was attributed to the strong ground motion that wrenched buildings out of square (Lawson, 1908; Youd and Hoose, 1978; Beltz, 2006; Dengler, 2008). During the earthquake, local Ferndale citizens reported that the ground rose and fell "in great waves like those of the sea" (Lawson, 1908, p. 165).

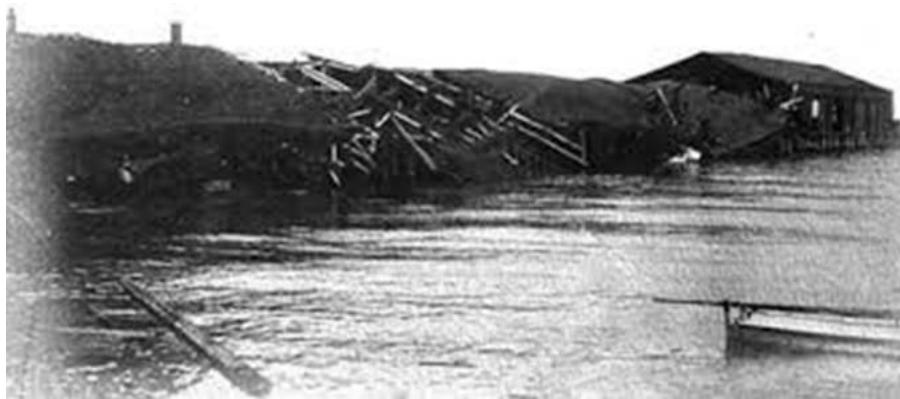
Figure SEQ Figure * ARABIC 5. Historical photograph of the Pacific Lumber Company dock at Fields Landing that collapsed from liquefaction triggered by the 1906 San Andreas fault earthquake. (Image reproduced from Dengler, 2008, her Figure 8.)

Eakle's field observations (published in Lawson, 1908) plus compilations of historical records by Youd and Hoose (1978) and Dengler (2008) also document significant deformation at Fields Landing (Figure 5), south

At Fields Landing,
liquefaction caused
significant lateral

spreading and ground settling or subsidence (Lawson, 1908; Youd and Hoose, 1978). A full meter of subsidence was recorded for an island in the channel off Fields Landing, and the Pacific Lumber Company dock was destroyed when the ground settled beneath it (Dengler, 2008) (Figure LF5). Ground settlement at Samoa was problematic for at least one of the large timber mills: "At Samoa, where the Vance Company has its mill and warehouses... one warehouse, the ground sunk beneath it several feet. The floor of the planing mill sank several inches on the east side and some are of the opinion that the factors settled also at one wall" (Youd and Hoose, 1978, p. 173). There are no observations concerning possible liquefaction for other areas of the North or South spits, nor—as with most of the other strong earthquakes after 1906—any information as to possible effects in offshore areas.
